Inspection Report

Property Address:

100 Good Street, Best Suberb
Auckland

Report Number	04151401
Inspection Date	15/04/2014
Inspection Time	04.15 p.m.
Weather Conditions	There appeared to have been RAINFALL IN THE PRECEDING 24 HOURS.
Recent Weather Conditions	Last rain within 24 hours

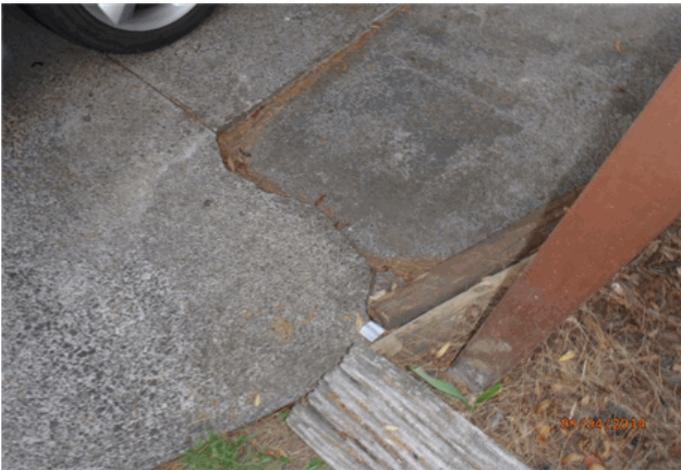
5) DRIVEWAY CONDITION

COMMON CRACKS AND SETTLEMENT WERE OBSERVED ON THE DRIVEWAY. This does not have any effect on the actual structural integrity of the dwelling itself - Maintenance is recommended. Note: Whilst these cracks appeared to be minor at the time of inspection, we strongly recommend you monitor these cracks and if worsening occurs contact a concreter for further advice.

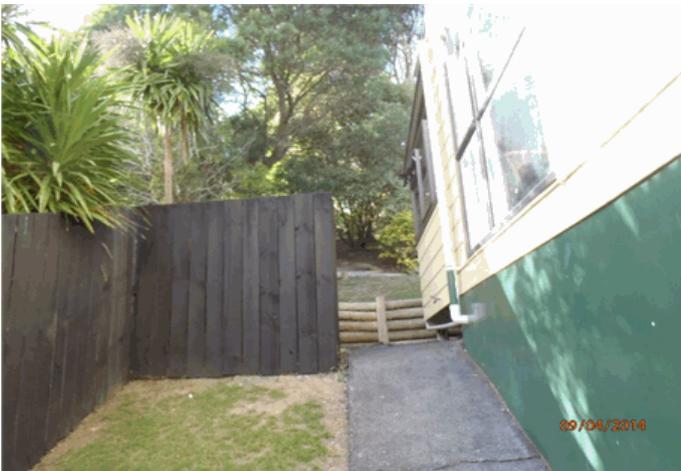
6) PATHWAYS CONDITION

Uneven settlements occurred along random cracks or shrinkage cracks, which may cause trapping accident. Recommend smooth out uneven surfaces by grinding concrete or re-lay pavers.

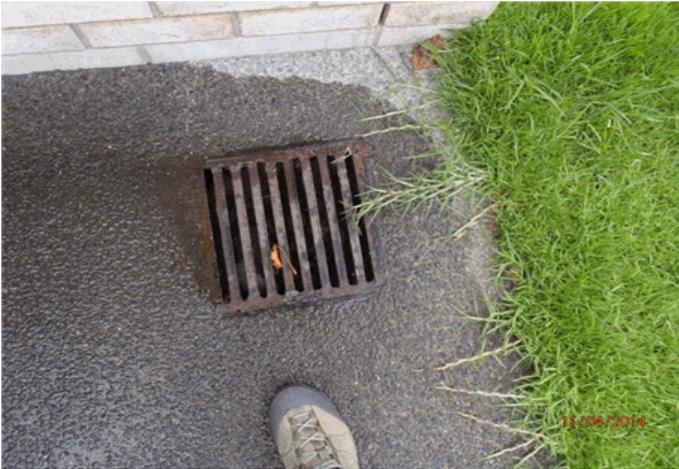
7) DRAINAGE FINDINGS

Silt traps are due for cleaning.

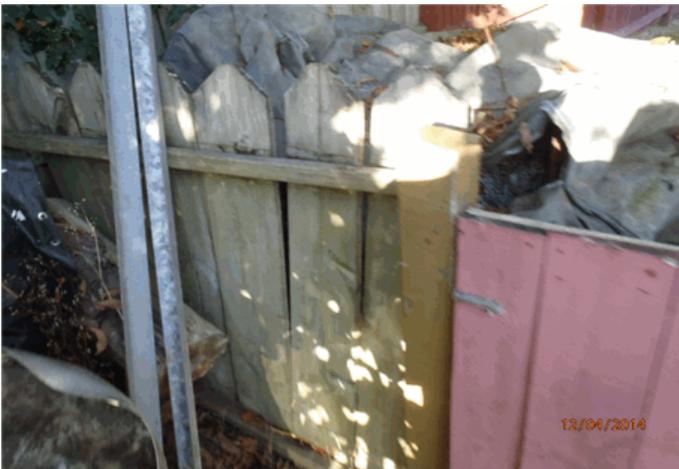
8) FENCE CONDITION

Most fence sections are aged. Gates are binding and damaged. Subject to general repair and replacement works by fencing contractors.

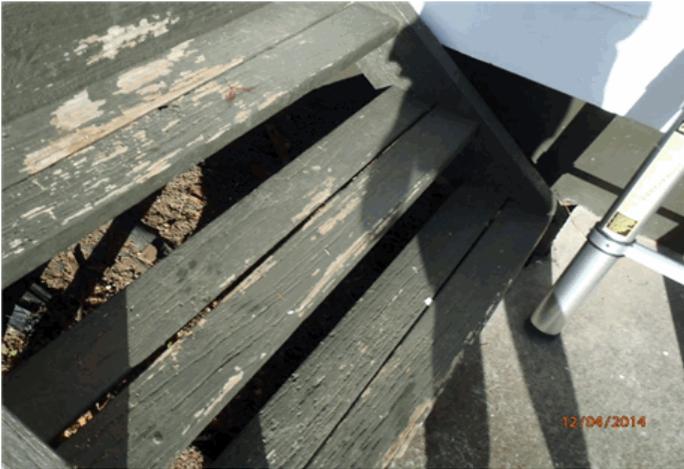
13) STEPS CONDITION

Aged and sagging timber treads to be repaired or replaced.

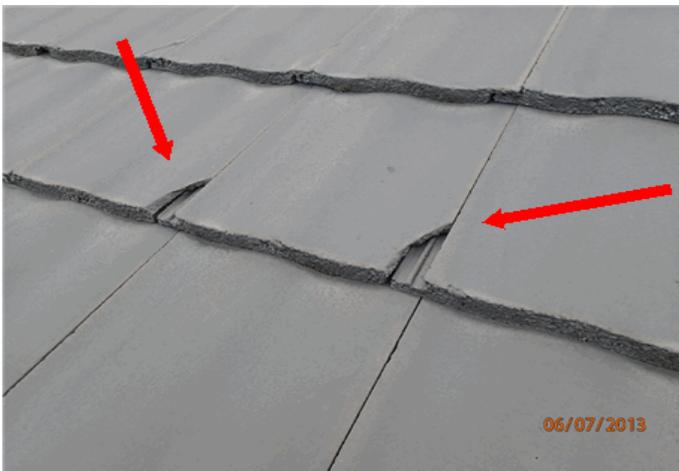
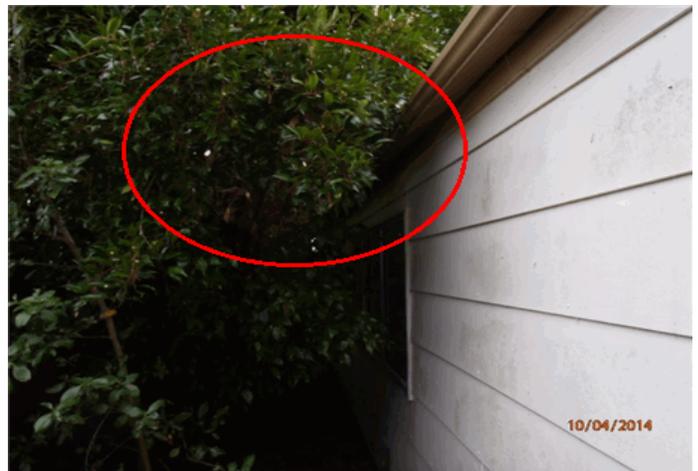
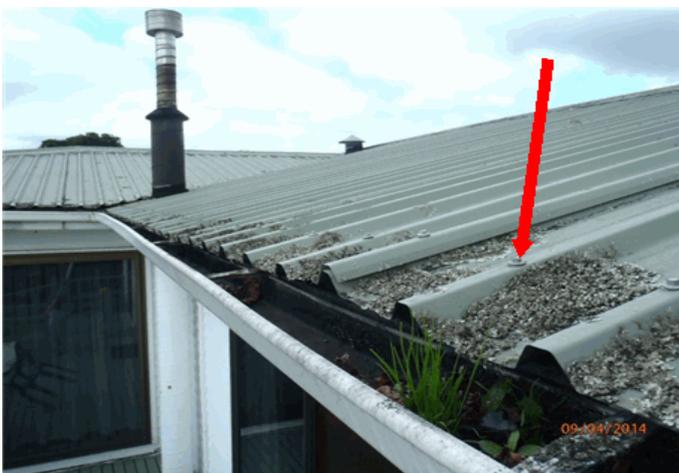
16) ROOF CLAD CONDITION **CRACKED TILES** visible - *Recommendations:* A Qualified roof tiling contractor should be engaged for advice and recommendations.
TREES OVERHANGING ON ROOF - *Recommendations:* Cut back to prevent damage and blocked guttering and associated problems.
 Growing lichens and moss on roof surface to be chemically treated and removed.

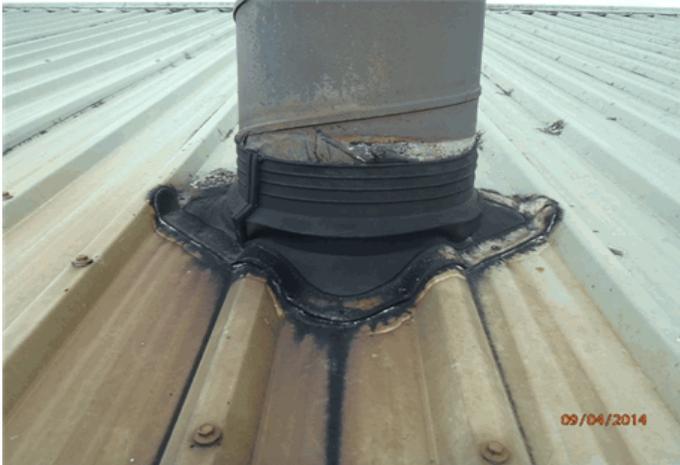
17) FLASHING CONDITIONS The indicated flashing appears severely deteriorated and due to be replaced or repaired by a suitably qualified roof maintenance specialist.

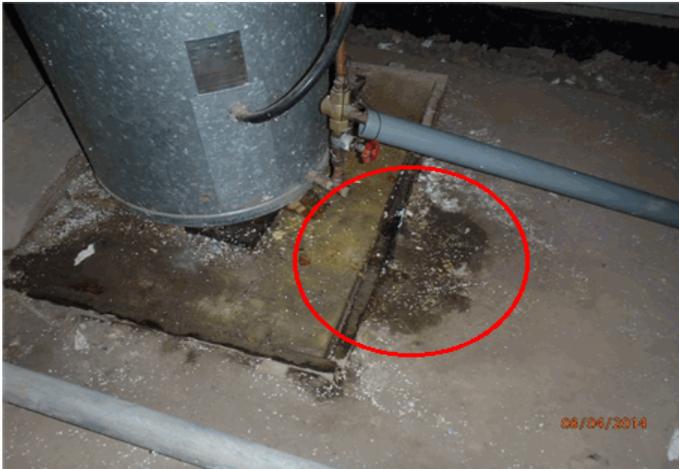
LEAKING OBSERVED from hot water unit observed at time of inspection.

Recommendations: Engage a licensed plumber to assess and rectify.

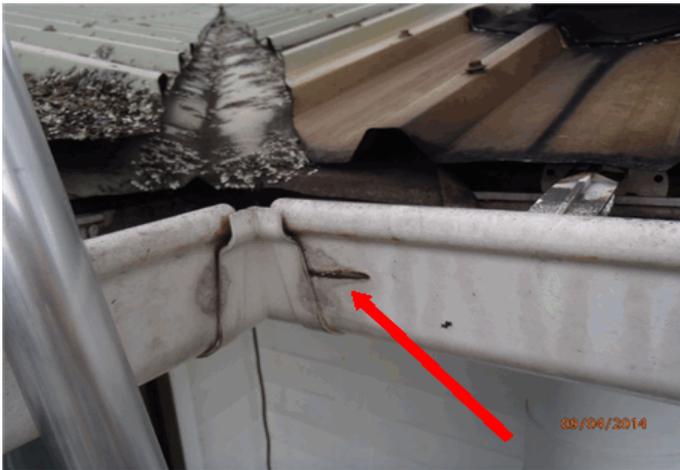
21) GUTTER FINDINGS

Cracked gutter section to be replaced by a plumber or roof maintenance specialist.

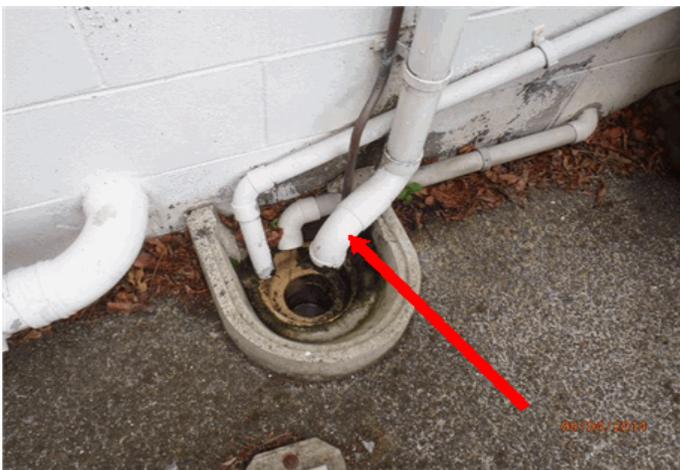
22) DOWN PIPE FINDINGS

The downpipe, which is discharging rainwater into sewer gully trap, must be properly connected and discharged into stormwater system.

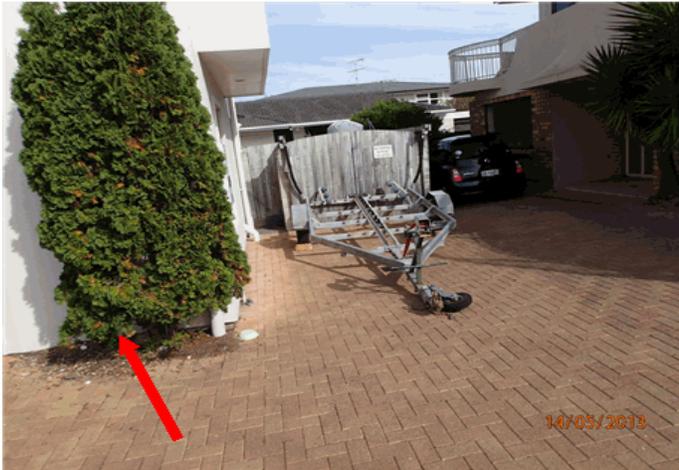
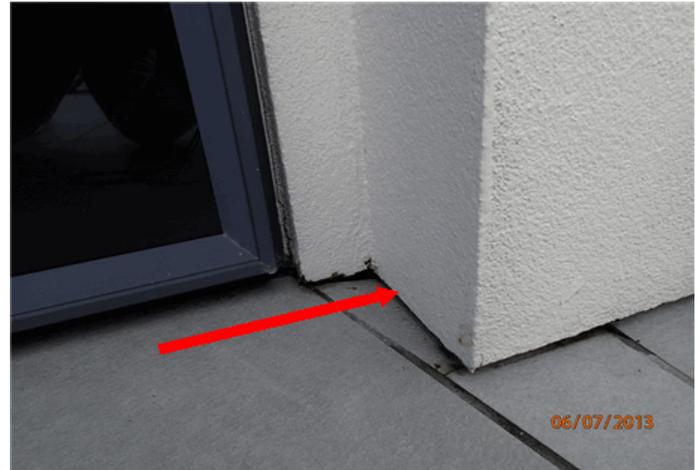
| 28) CLEARANCE FINDINGS | Wall cladding to indicated area has been brought down to ground level without clearnace for ventilation and drainage purpose. Lack of ground clearance may result with moisture ingress into framing |

structure by wicking and capillary action. Cladding based to balcony floor clearance appears insufficient. Mould growth on bottom edge of wall cladding may indicate potential moisture ingress, which to be further investigated.

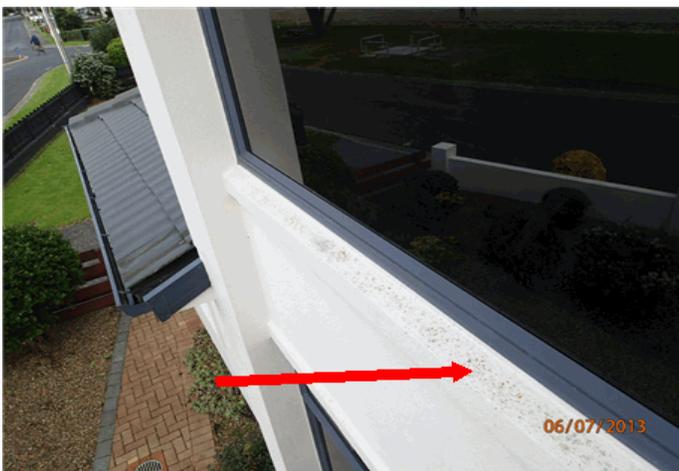
29) COATING FINDINGS

Mould and lichen are growing on beveled sill surface. Persistent growing of lichen on cladding surface may degradate the coating and cause premature coating failure. Ensure regular washing and cleaning to wall cladding with well teste
 Mould and lichen are growing on beveled sill surface. Persistent growing of lichen on cladding surface may degradate the coating and cause premature coating failure. Ensure regular washing and cleaning to wall cladding with well tested and proofed cleaning product.

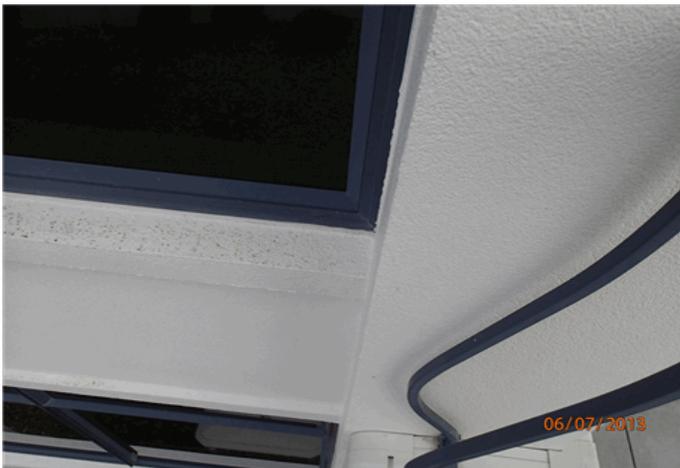
34) SILL DETAILS

No sill flashings are installed for all windows and doors penetrating wall cladding. PVC strips installed around window penetrations were called "window flashings" at the time, but do not function as flashings, because they do not provide means for moisture to escape from behind.

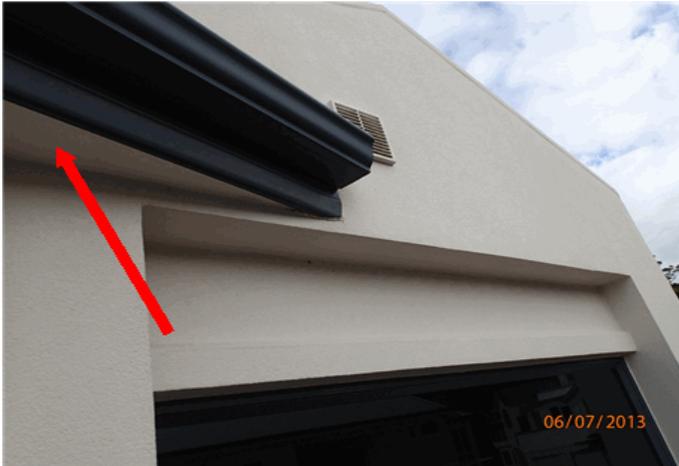
39) EAVE CONDITION

EAVE LINING STAINS detected. Normally this occurs due to overflow in blocked gutters. *Recommendations:* Gutters should be kept clear of debris and eave linings can then be painted or repaired as required.

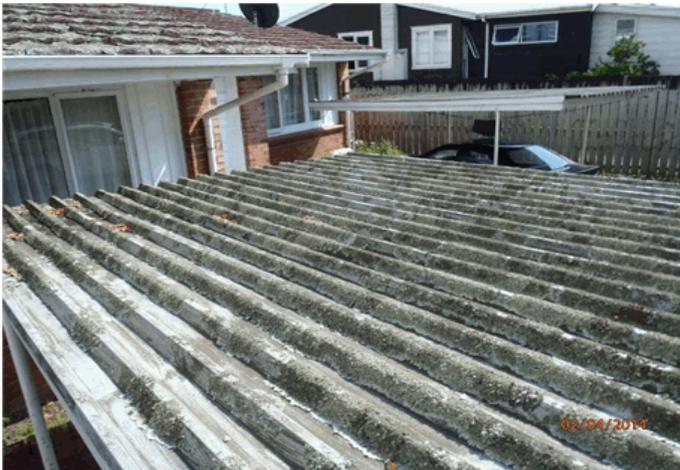
42) ROOF AND GUTTER **MOSS HAS BUILT UP** on the cladding over time. It is preferable to have removed / cleaned to prevent deterioration. Recommendations: A Qualified roof restoration contractor should be engaged for advice and recommendations.

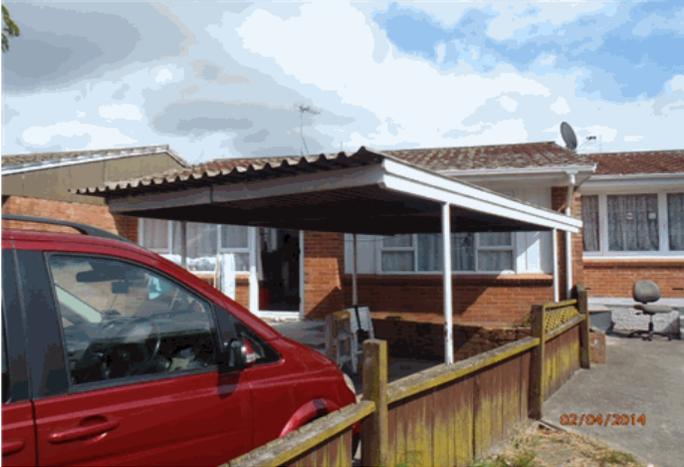
49) STRUCTURE FINDING Diagonal bracing to be provide for steel framing to limit lateral movements.

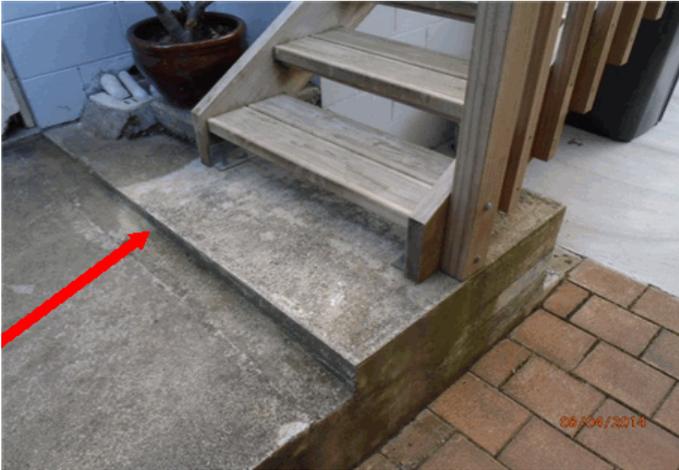
50) OVERALL CONDITION

Of areas visible, **POTENTIAL SAFETY HAZARDS WERE EVIDENT**
 Uneven concrete pad on bottom of exterior stair may cause trapping accident.
 Care to be taken when stepping on.

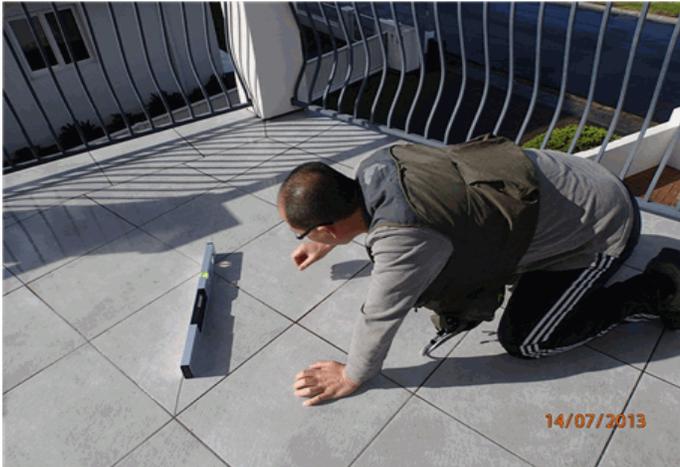
62) FLOORING

WATER PONDING evident - Balconies should be constructed with adequate fall to a drain and ponding water may expedite deterioration and leaking.

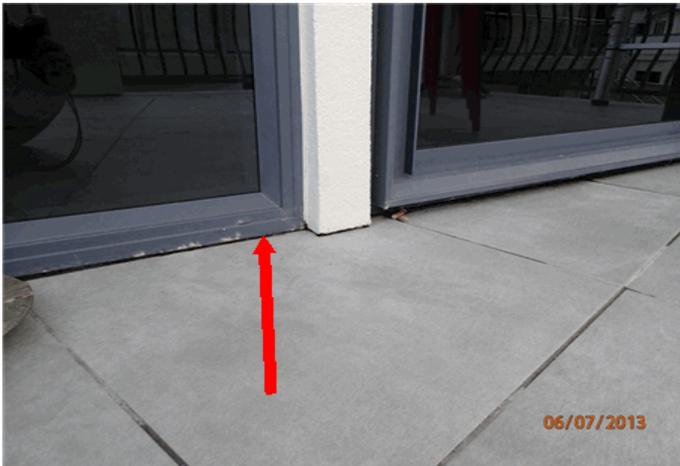
63) FLOOR TO SILL JUNCTION

Door sill to balcony floor clearance insufficient. Lack of sufficient sill clearance may result with leaks by splashing and wicking.

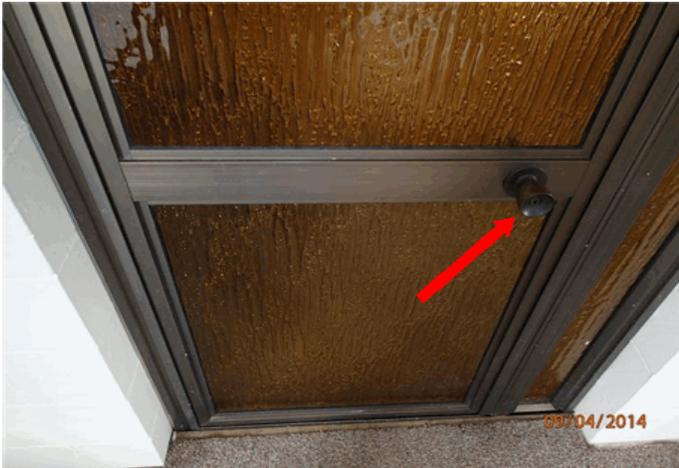
70) Front Entry Doors

THE ENTRY DOOR LOCK WAS DAMAGED/DETERIORATED -
Recommendations: A locksmith should be engaged for advice and recommendations.

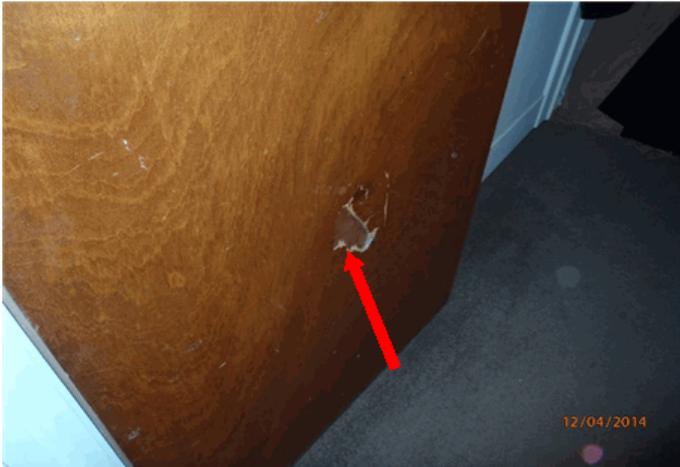
73) Door

Some punched holes are noticed to some interior door panels. Repair works normally can not recover the original condition. For better result, replacement of affected panels may be the more economical solution.

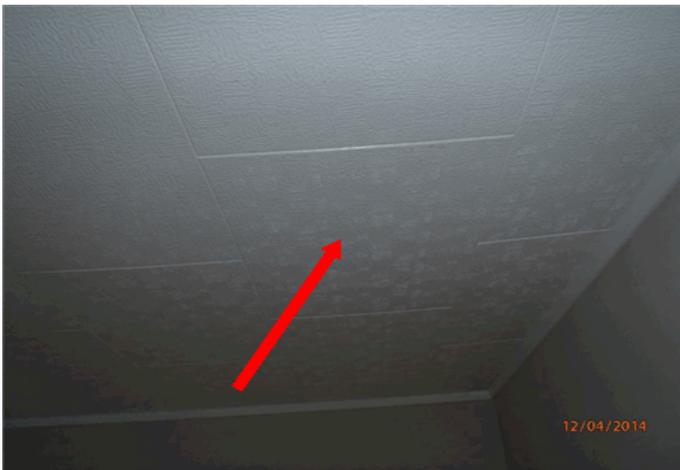
74) Ceiling

Some ceiling tiles in bedrooms and hallway appear sagging. No current elevated moisture recorded, but to be monitored during wet season.

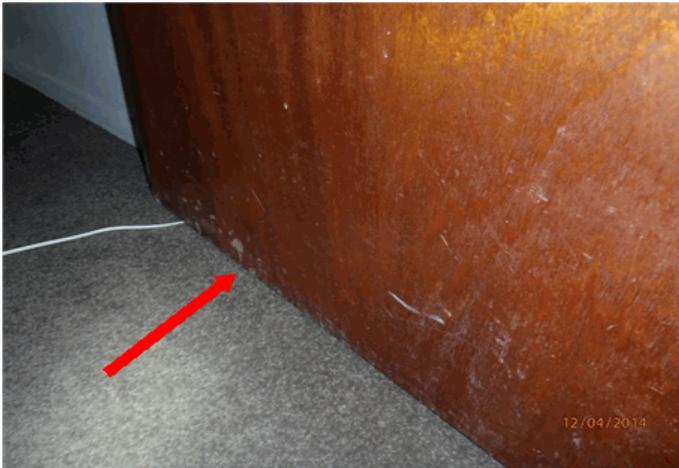
110) Door

Door bottom edge showing delamination of laminated surface ply. Repair by professional or repalce to client wish.

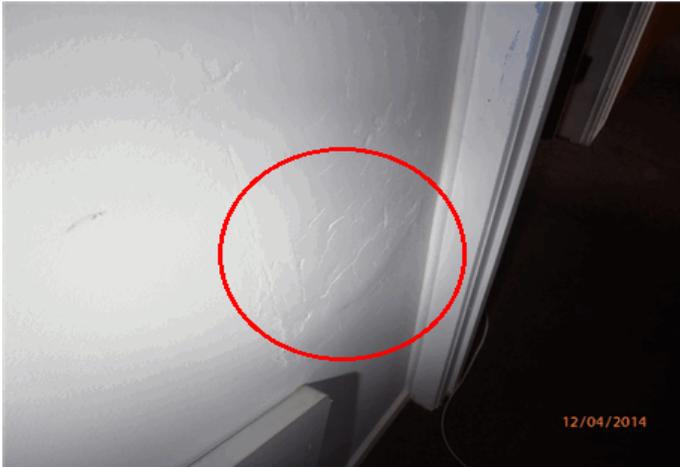
112) Walls

Patching repair works poorly carried out. Indicated area to be replastered by a professional.

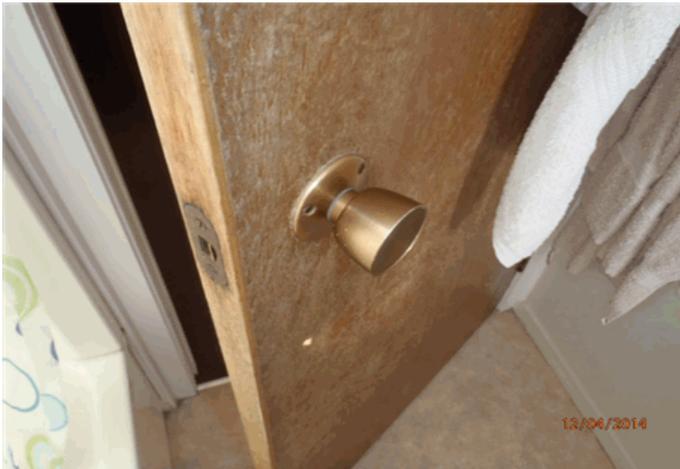
140) Door

DOOR / FRAME DETERIORATION - General age/damage has occurred to door frame, face or components. Recommendations: Recoating for door panel is recommended.

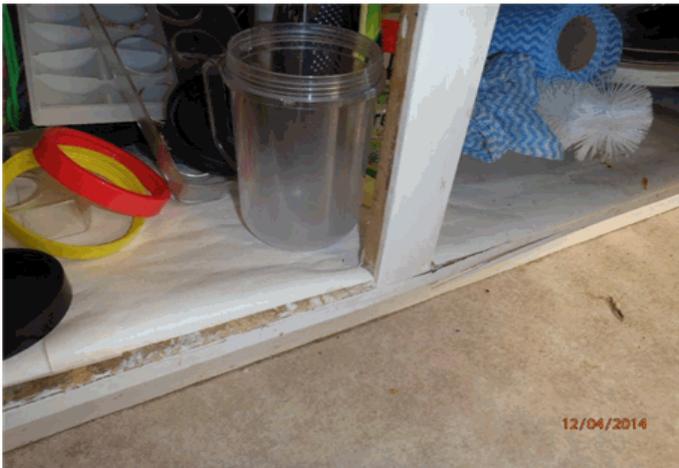
**182) Cupboards And Bench
Tops**

Some swelling MDF boards and panels appear caused due to long term splash. Adequate to the age. Can be replaced or repaired by professional.

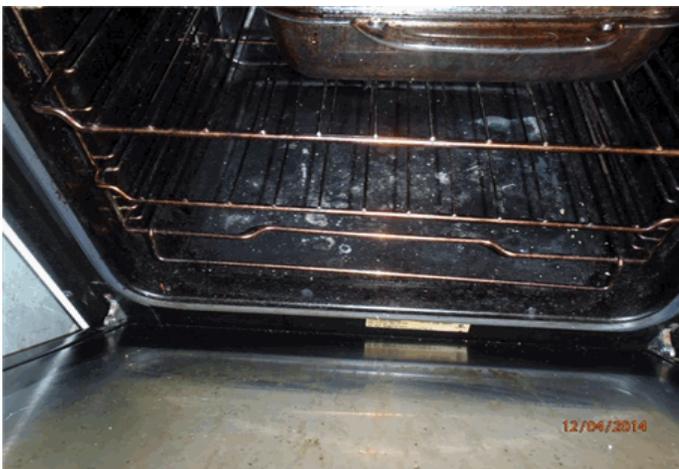
**185) Oven**

Heavy grease inside the oven to be chemically cleaned. The oven appears in working order at the time of inspection.

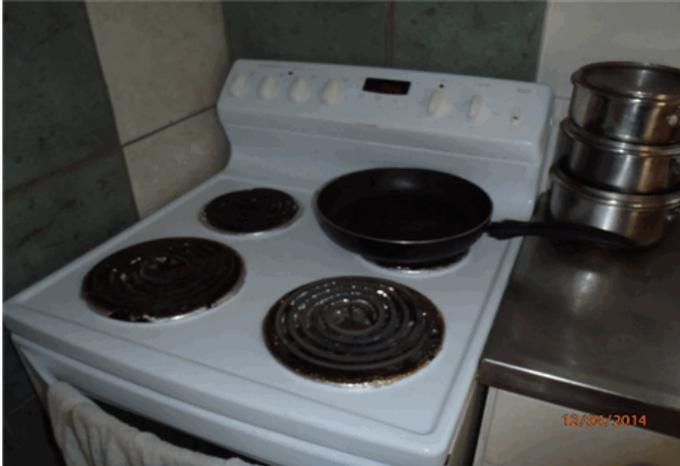
186) Cooktop

Lack of general cleaning resulted with heave grease residue on cooktop surface. Chemical cleaning is recommended.

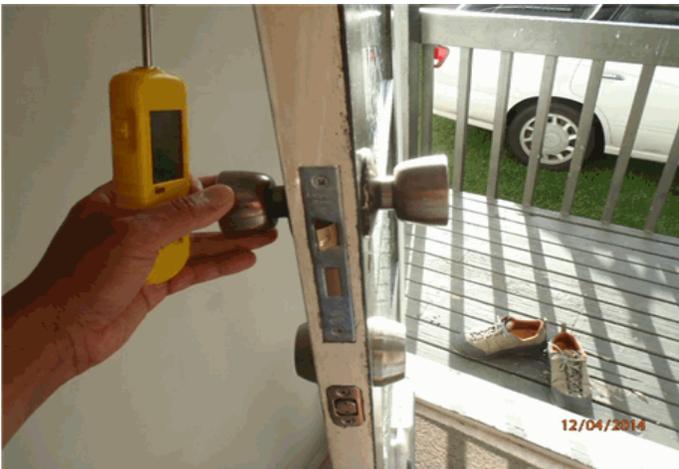
196) Door

THE LAUNDRY DOOR LOCK IS DAMAGED - Recommendations: A locksmith should be engaged for advice and recommendations.

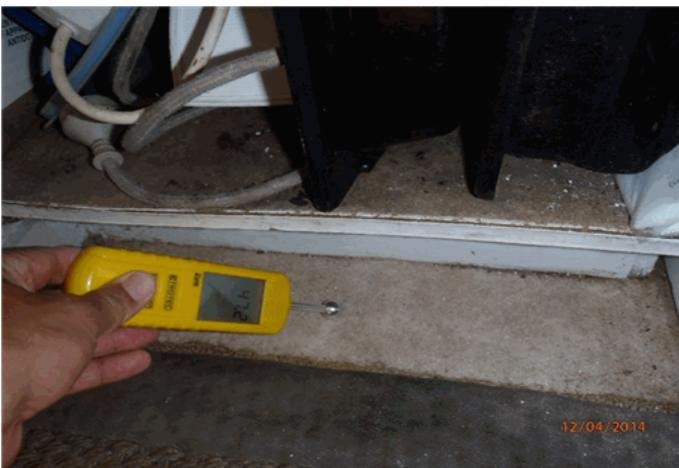
201) Taps and Tub

GENERAL DETERIORATION and wear to sink, cupboards and benches.
Recommendations: General maintenance works required.
Swelling MDF panels due to long term water splash observed.

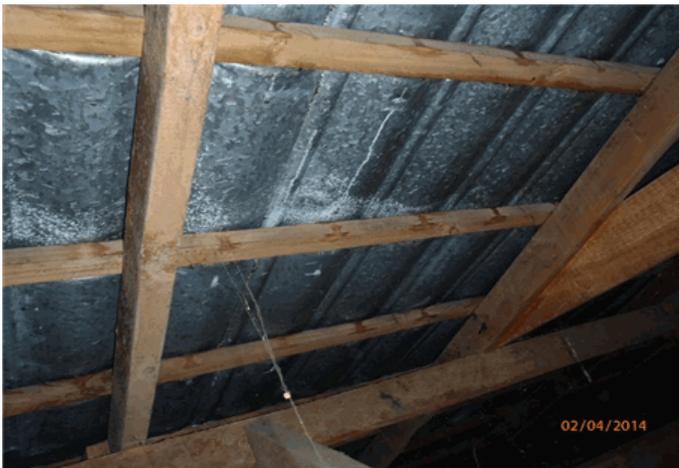
207) ROOF UNDERLAY

No roof underlay installed as a second defence for leaks. When retro-fitting roof underlay is not planned yet, ensure well applied ceiling insulation may reduce chances of damaging ceiling lining by roof leaks.

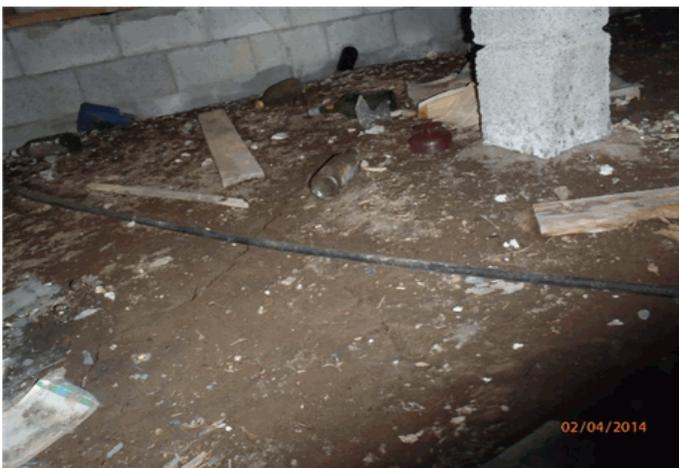
216) DAMPNESS

DAMPNESS IN SUB FLOOR SOIL - (not ponding). Damp sub floor soil should be avoided as it can cause fungal decay, mould and possibly footings problems Recommendations: A Qualified drainage engineer or plumber should be engaged for advice and recommendations.

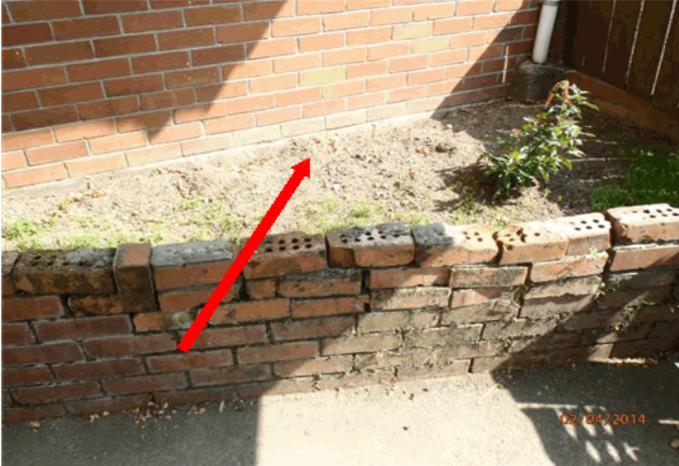
217) VENTILATION

Subfloor ventilation appeared to be limited to area indicated. This may be conducive to Timber decay. Improvement to the ventilation is recommended. Contact a Licensed Builder for advise and rectification.

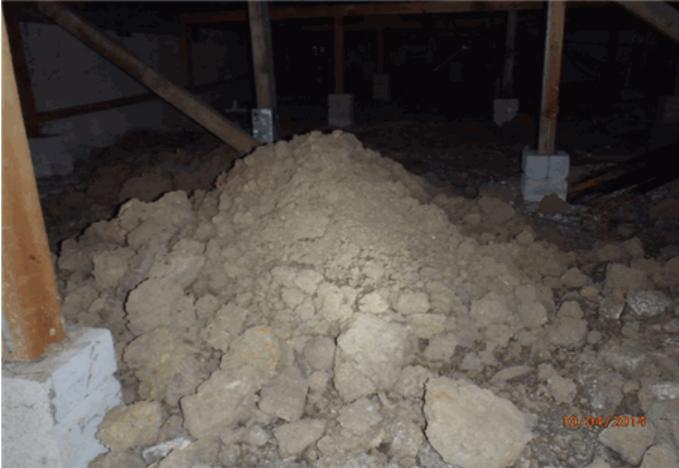
218) SUBFLOOR CLEANLINESS

Excessive amount of dirt and waste to be removed from subfloor space to enhance ventilation and for ease of repair and maintenance.
