Inspection Report

Property Address:

100 Good Street, Best Suberb
Auckland

Report Number	04151401
Inspection Date	15/04/2014
Inspection Time	04.15 p.m.
Weather Conditions	There appeared to have been RAINFALL IN THE PRECEDING 24 HOURS.
Recent Weather Conditions	Last rain within 24 hours

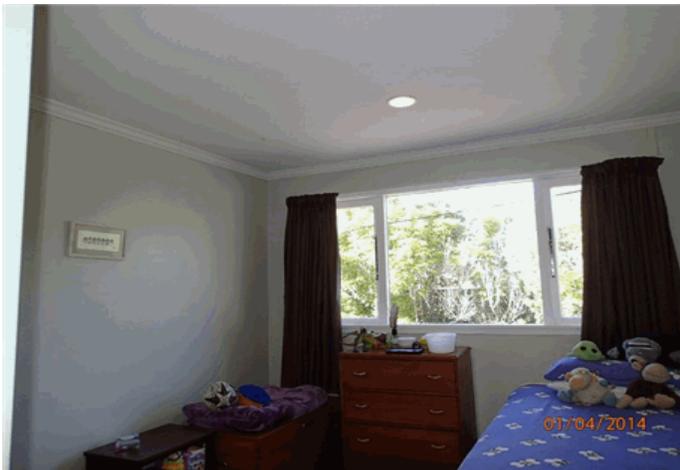
115) Overall Condition

Overview photo of subject area. For information only
On visual inspection, the general condition of this area is Acceptable for the age.
